# THE ENGINEERING GEOLOGY OF FRANKTON ARM.

A thesis  
submitted in partial fulfilment  
of the requirements for the degree  
of  
Master of Science in Engineering Geology  
in the  
University of Canterbury  
by  
**DEBORAH LOUISE STOSSEL**

University of Canterbury,  
June, 1999.

Seven bedrock landslides situated within quartzofeldspathic schist exist up slope of the residential area along the Frankton Arm of Lake Wakatipu, South Island, New Zealand. Engineering geological and geotechnical failure models for these landslides have been established using engineering geological mapping at scales of 1:5000 and 1:10000, geotechnical testing, and the development of limit-equilibrium sensitivity models.

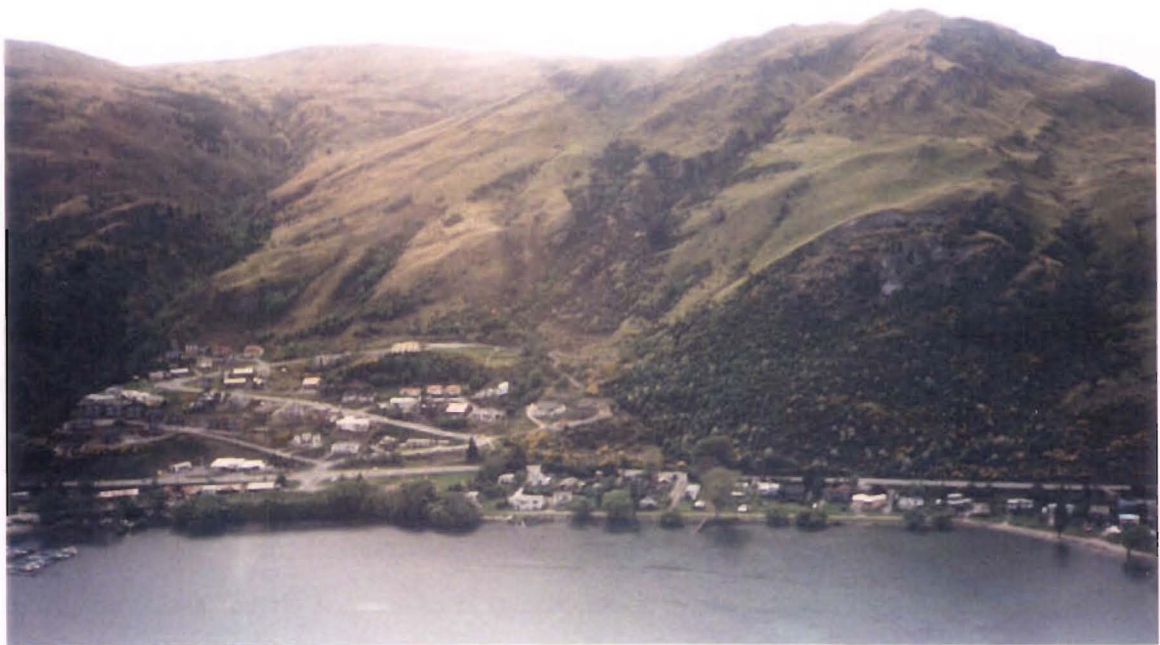
Figure 5.5: Photo looking north over Frankton Arm at the Marina Heights and No. 2 failures in relation to the subdivision. Note Marina Heights Extension Subdivision in relation to Slide No. 3.

Residential development does not occur on the landslide mass (which extends from 440m above sea level to 680m above sea level), however, directly down slope the Marina Heights residential area occurs, with development extending from lake level up slope to approximately 390m above sea level (figure 5.5).

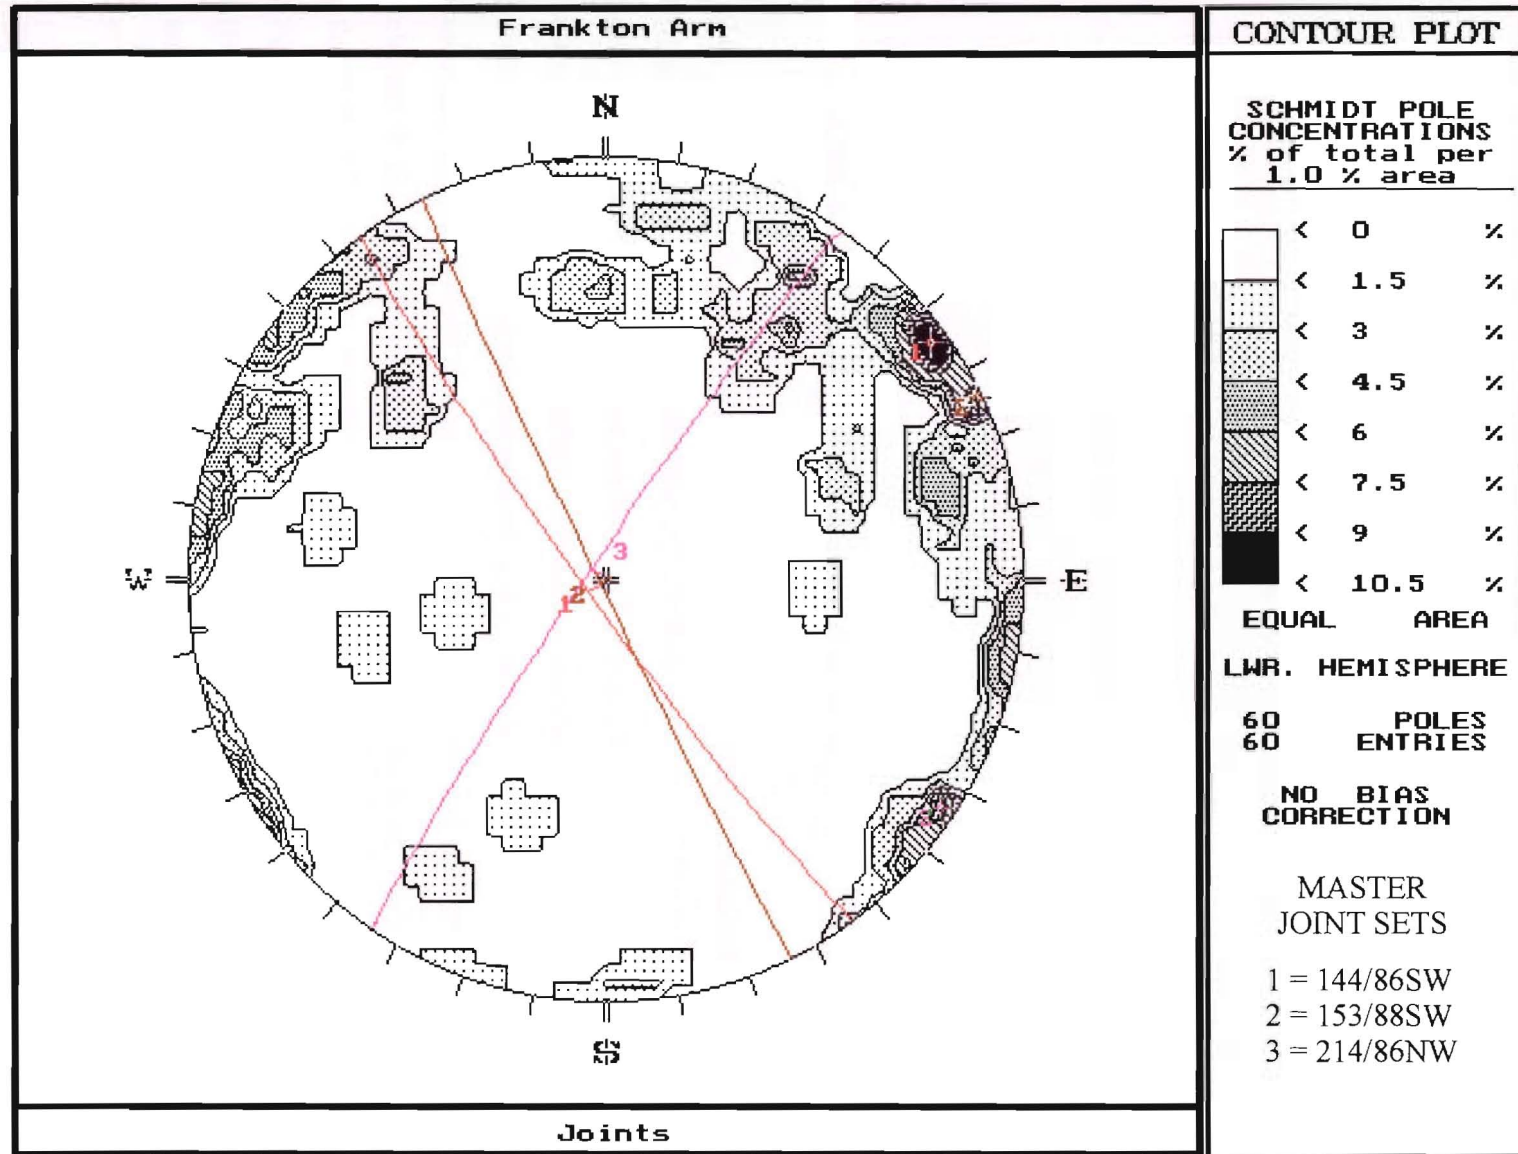
Figure 5.6: Stereoplot showing master joint sets along Frankton Arm.

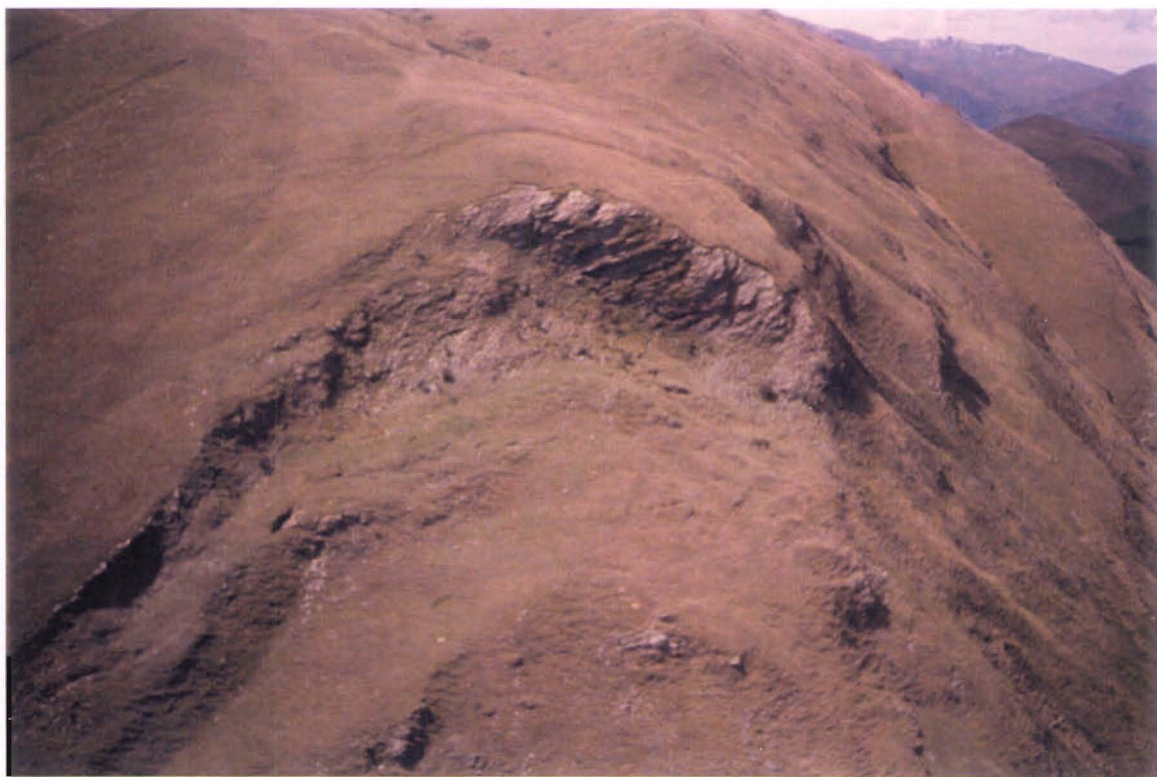
Figure 5.7: the Marina Heights head and lateral scarps. Photo taken looking east.

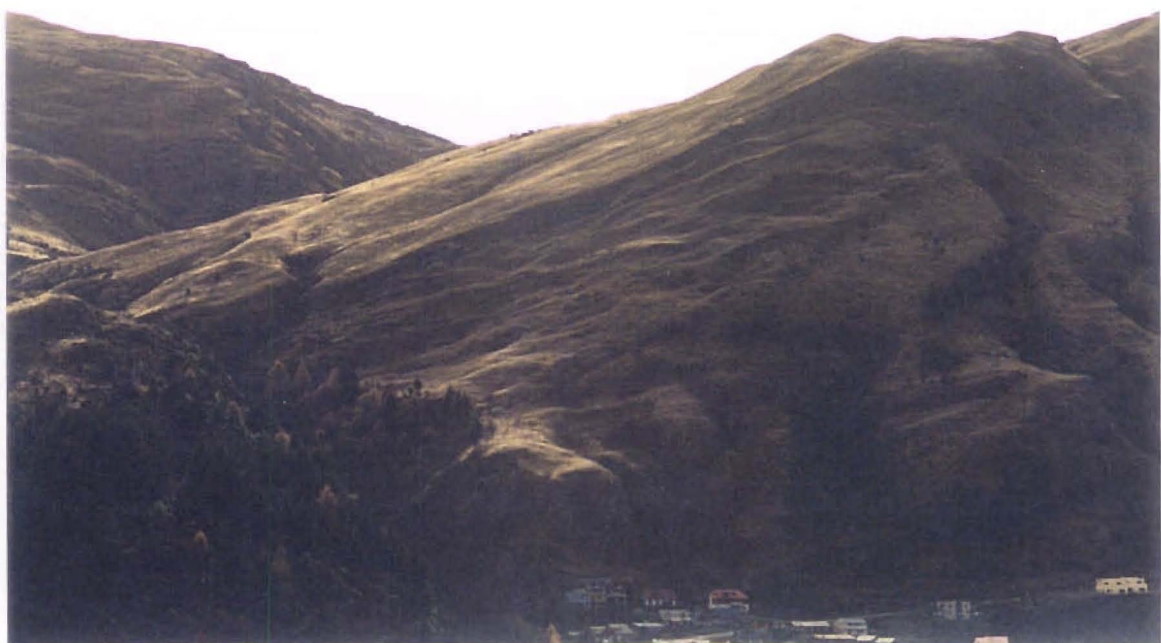
Figure 5.8: Hummocky topography of the Marina Heights landslide.

Aerial photographs from the 1950's have shown that there has been no visual changes in landslide morphology since then. The head scarp runs northwest southeast (figure 5.7) and then trends northeast southwest forming the lateral scarp (figure 5.1). The scarps within the failure are all degraded, and a small minor failure towards the west in the southern corner also appears in the 1950's aerial photographs, thus cannot be attributed to recent movement. The entire slide mass has hummocky topography, indicating most of the slide mass is made up of displaced schist blocks that have moved down slope towards the west (figure 5.8).

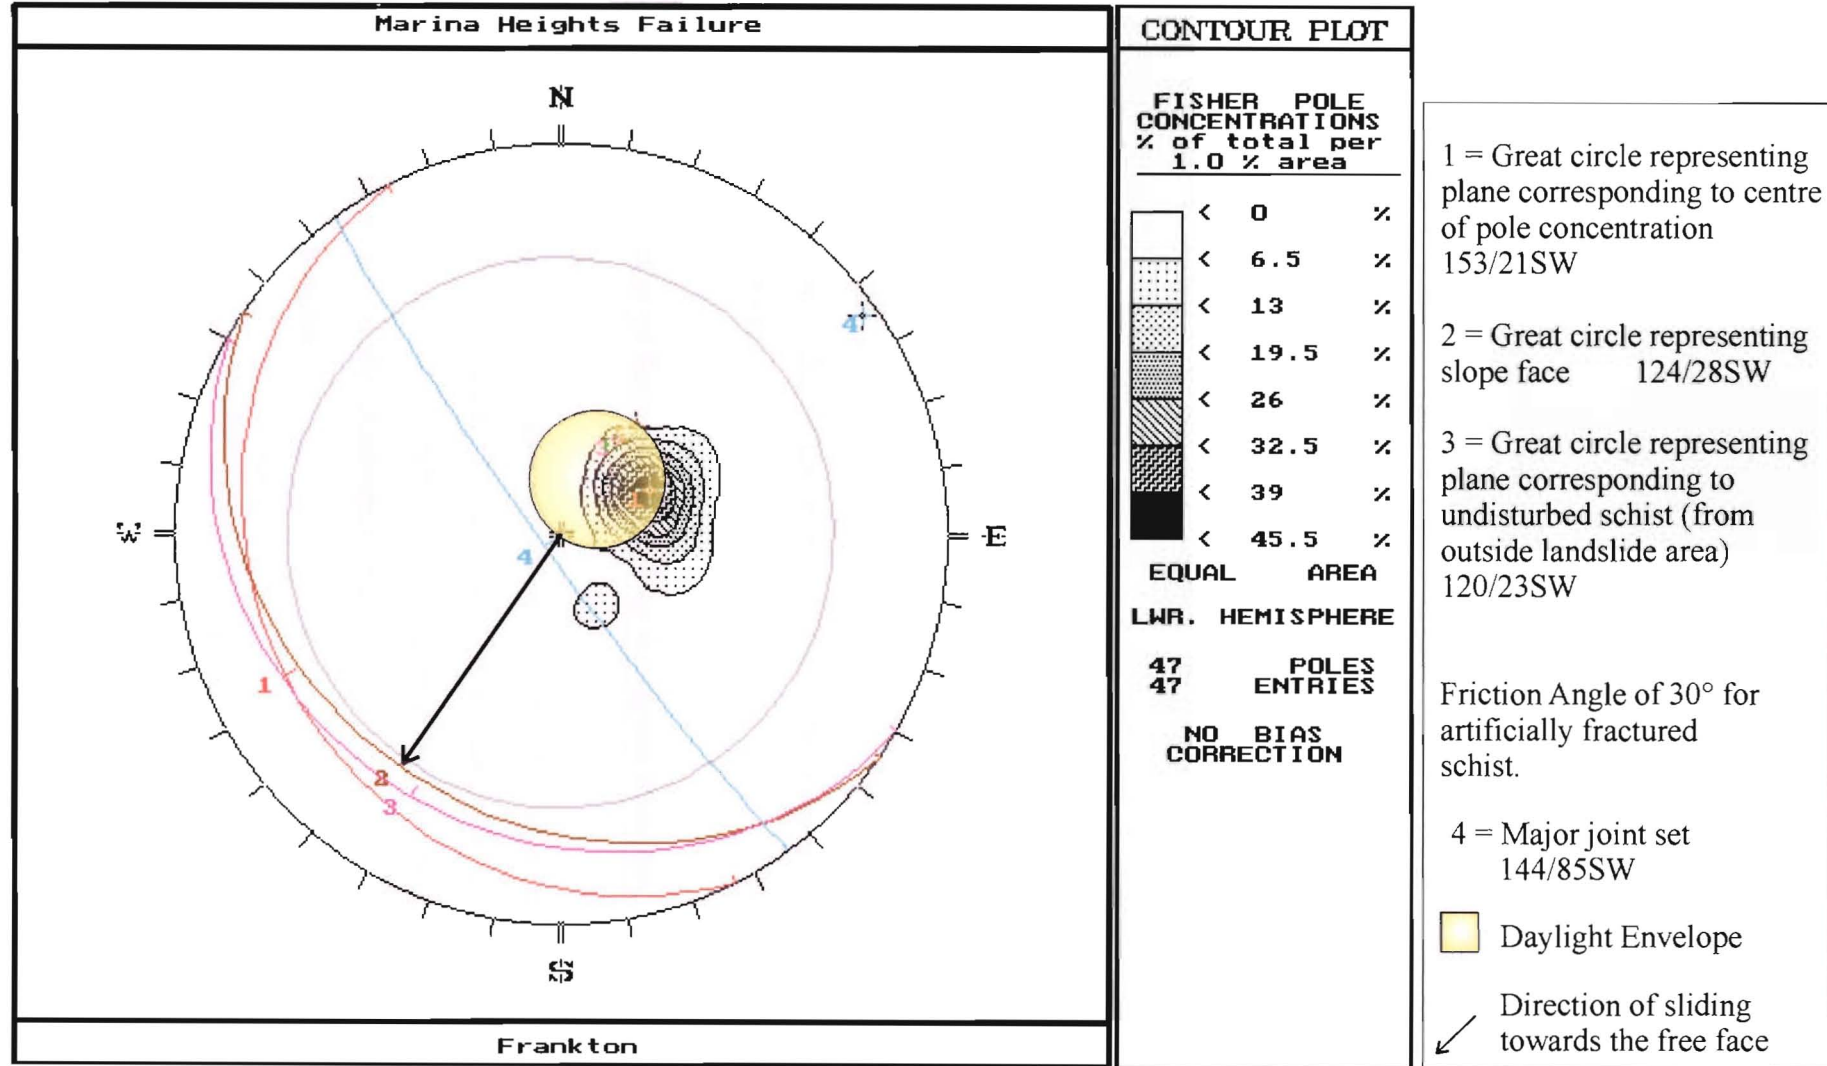
Figure 5.9: Stereonet showing major structural controls of the Marina Heights Failure, using a friction angle of 30°, a value obtained from laboratory testing of artificially fractured schist collected from outside the slide area. There is no Markland's zone of instability formed.

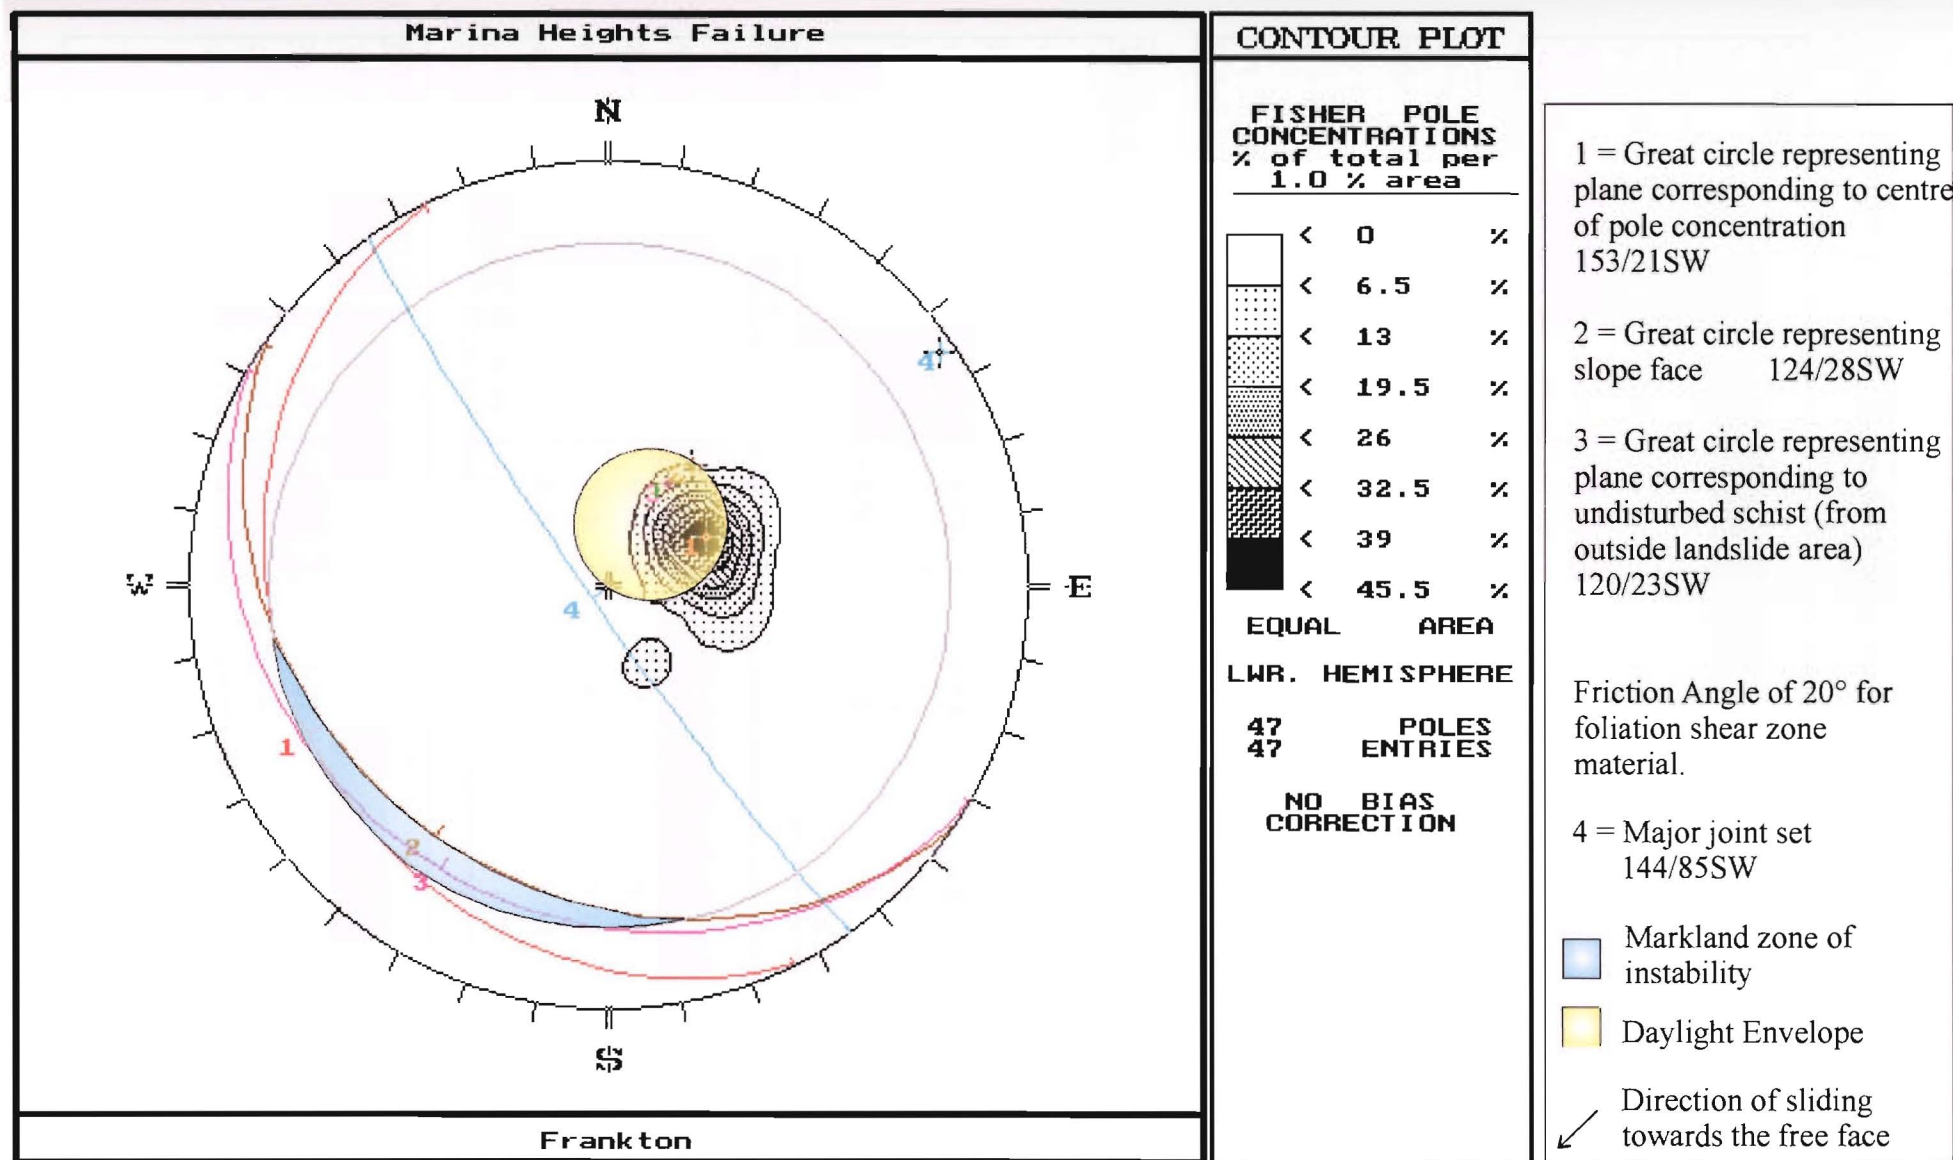
Figure 5.10: Stereonet showing major structural controls of the Marina Heights Failure, using a friction angle of 20°, a value assumed for foliation shear zone material. There is a Markland's zone of instability formed.

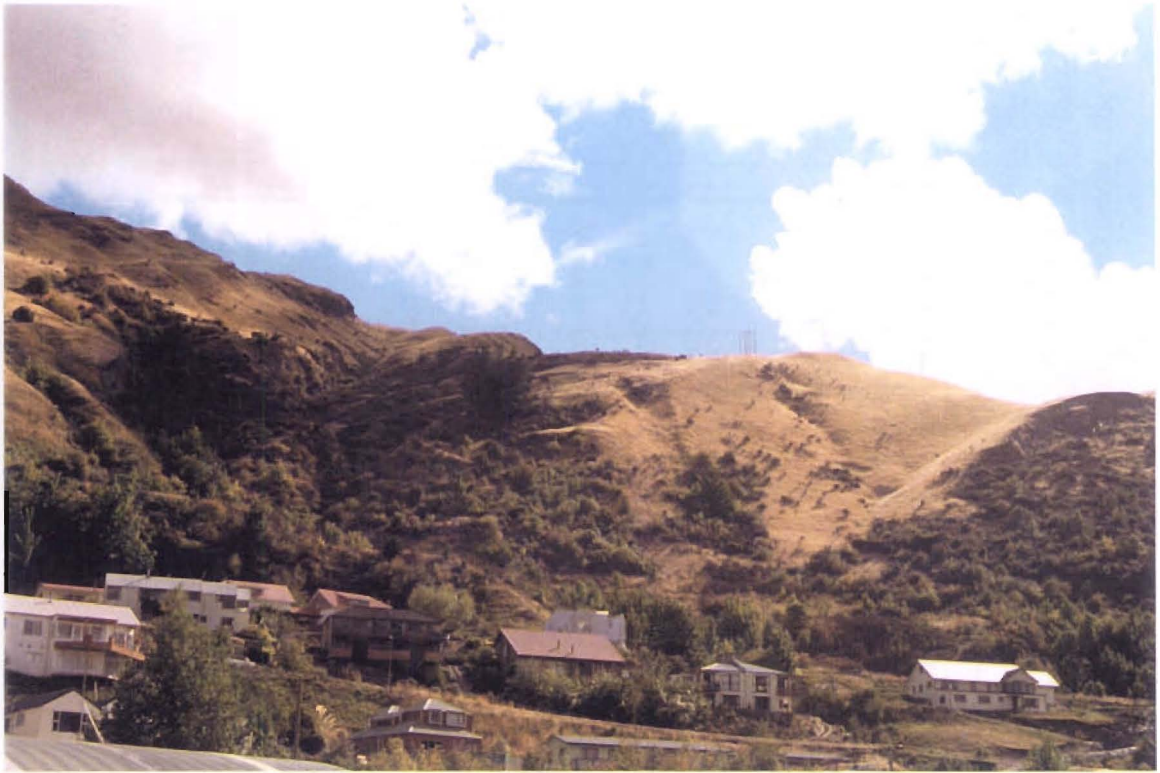
Figure 5.11: Slide No. 2 (in the centre of the photo) with the head scarp at the sky line. Note well-established pine tree in the lower part of the slide. Slide No. 4 is at far right.

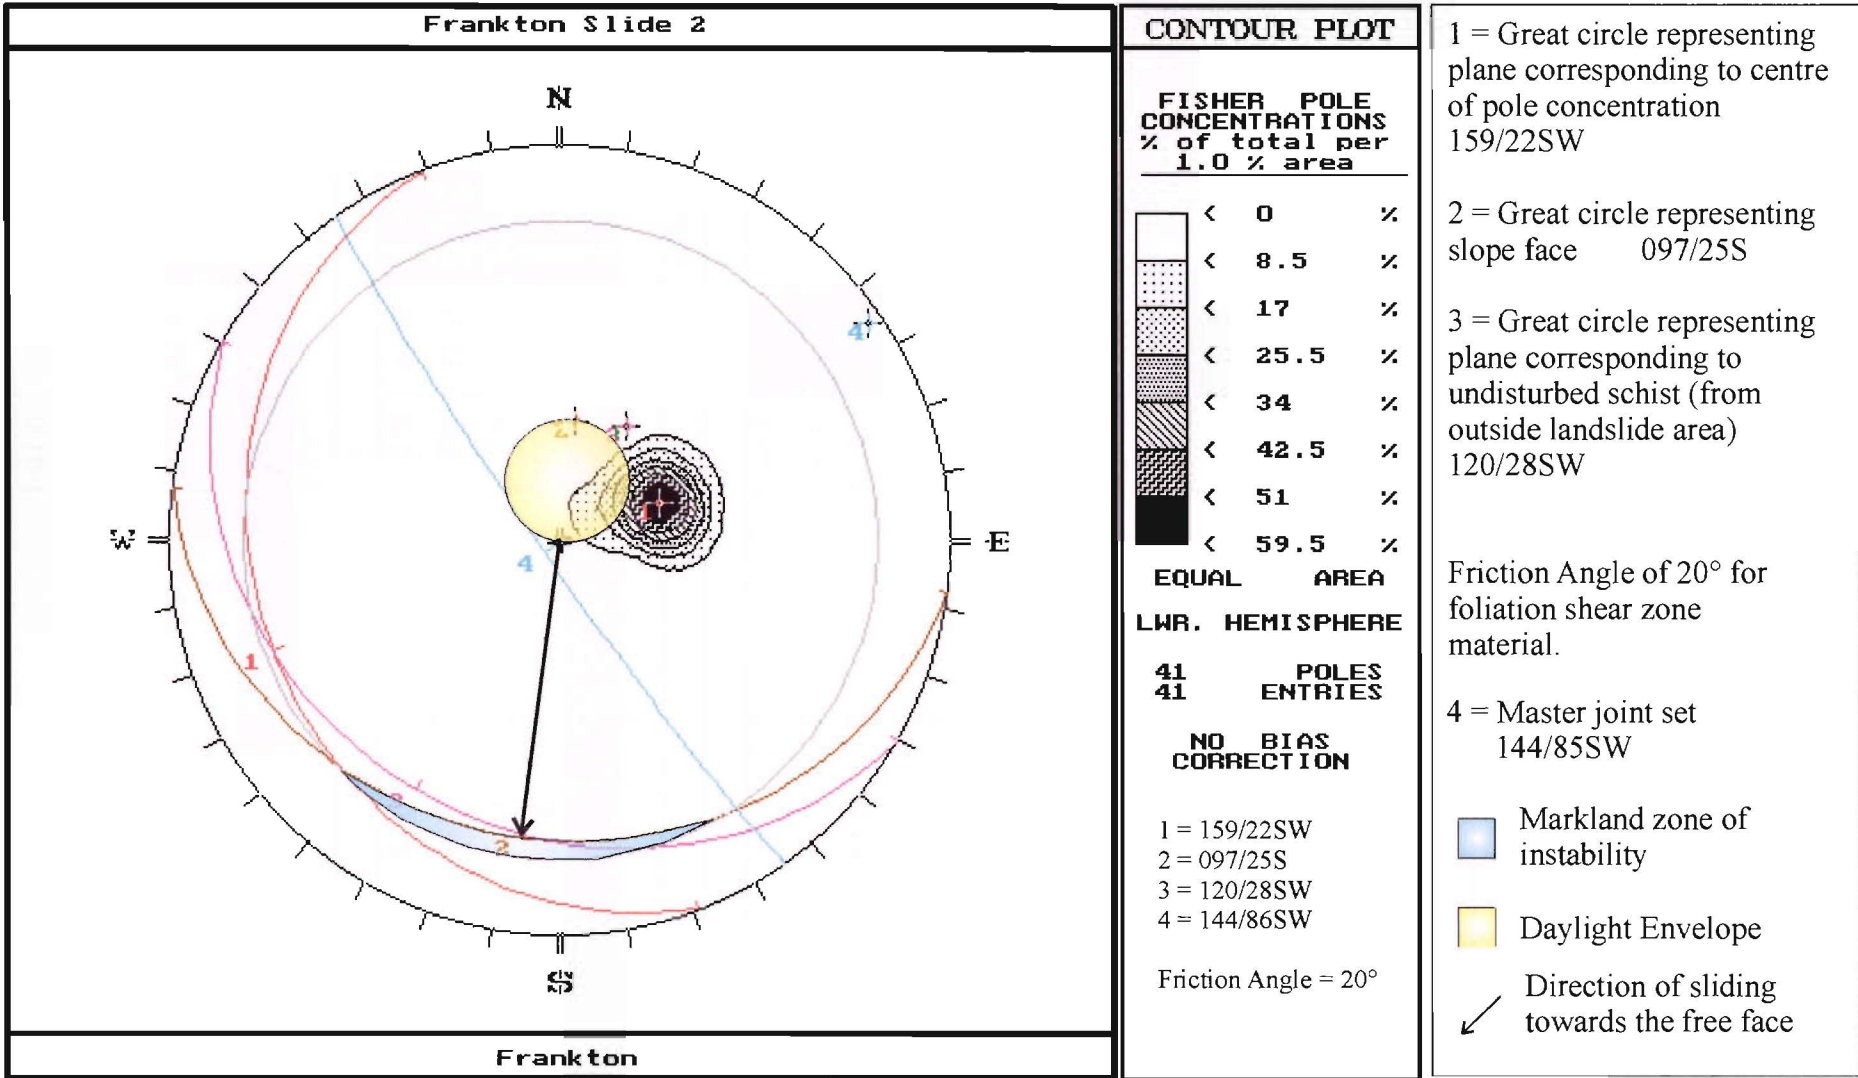
Figure 5.13: Stereonet showing major structural controls of Slide No. 2 Failure, using a friction angle of 20°, a value assumed for foliation shear zones. There is a Markland's zone of instability formed.

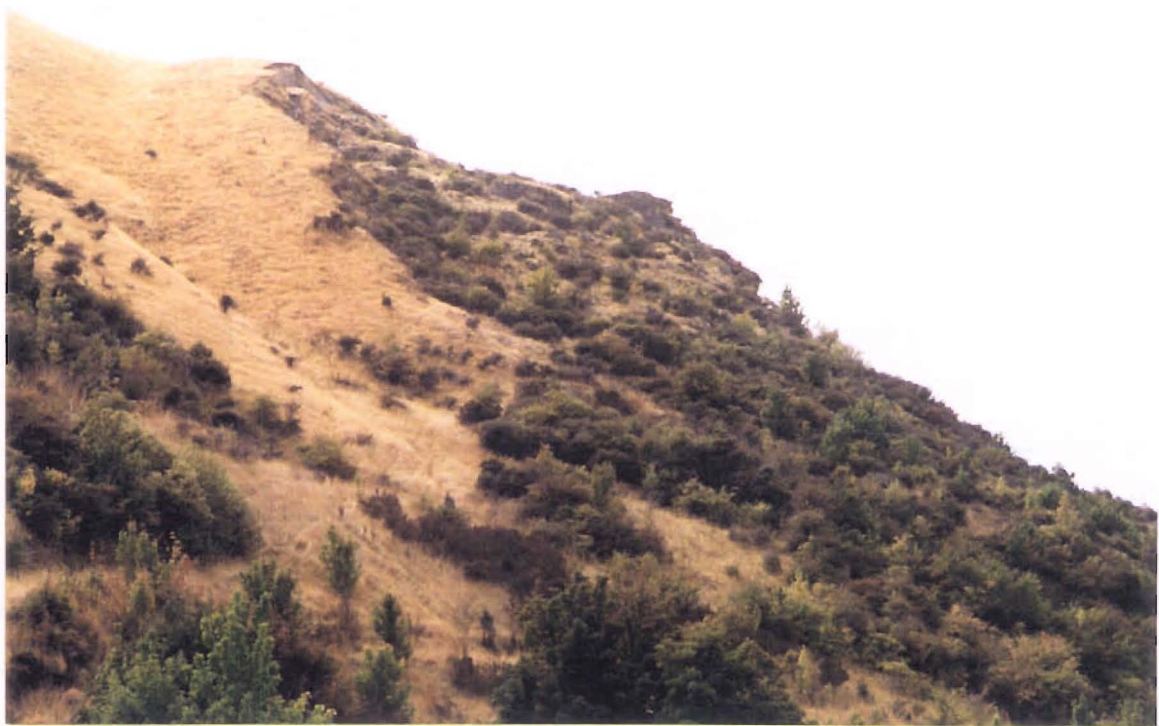
Figure 5.14: Slide No. 3 sub-vertical to over-hanging head scarp. Note prominent displaced schist blocks and down slope relaxation. Photo taken looking east.

The head scarp has formed along joints dipping about  $60^\circ$  to the south and in places is sub-vertical to overhanging (figure 5.14). An area immediately below the head scarp contains a number of displaced schist blocks ( $>10 \text{m}^3$  and some up to 20m in length). Within the head scarp the dip of the schist is variable (ignored in simplified analyses), and large wedge failures have taken place from within the head scarp. Various seepage zones are present in this area, however no vegetation has become established within the displaced blocks, as the most recent failures have been approximately 100 years ago (estimated from the amount of vegetation that has become established – such as lichen, and by the freshness of cracks and

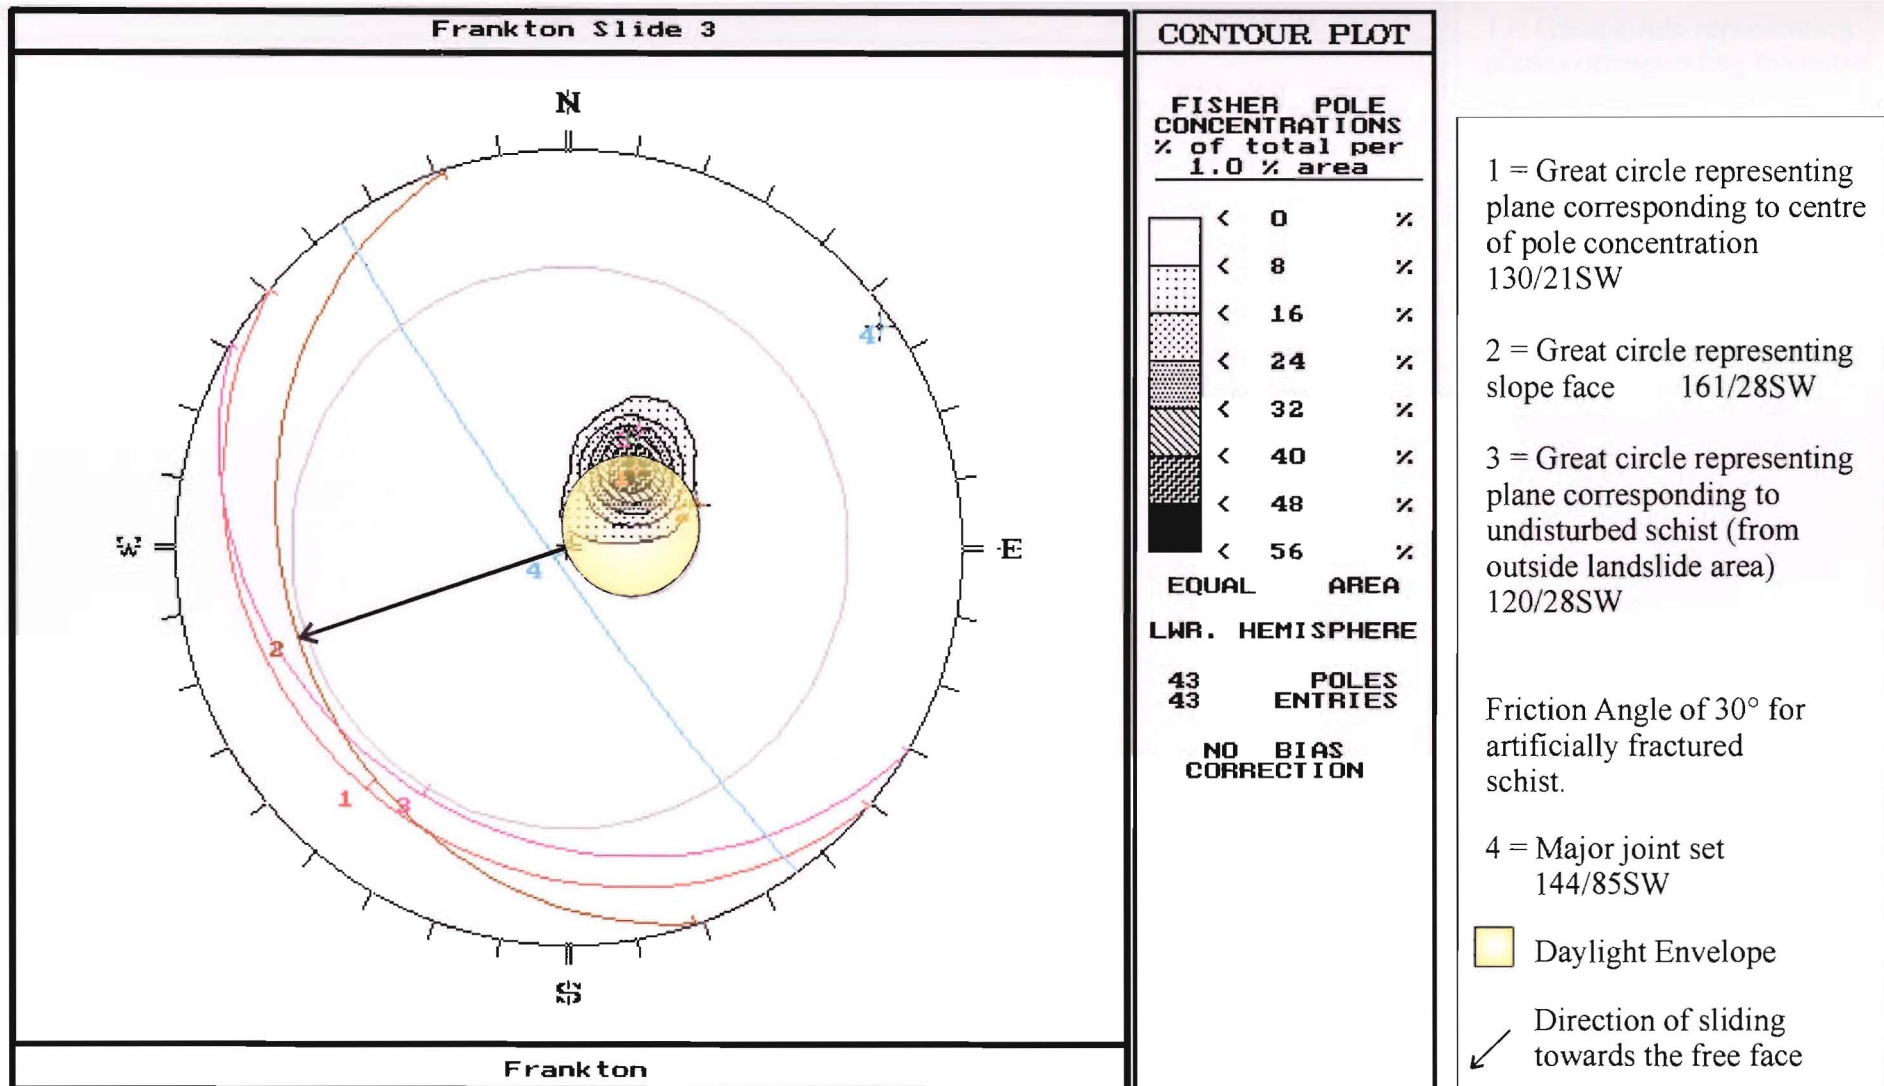
Figure 5.15: Stereonet showing major structural controls of the No. 3 Failure, using a friction angle of 30°, a value obtained from laboratory testing of artificially fractured schist collected from outside the slide area. There is no Markland's zone of instability formed.

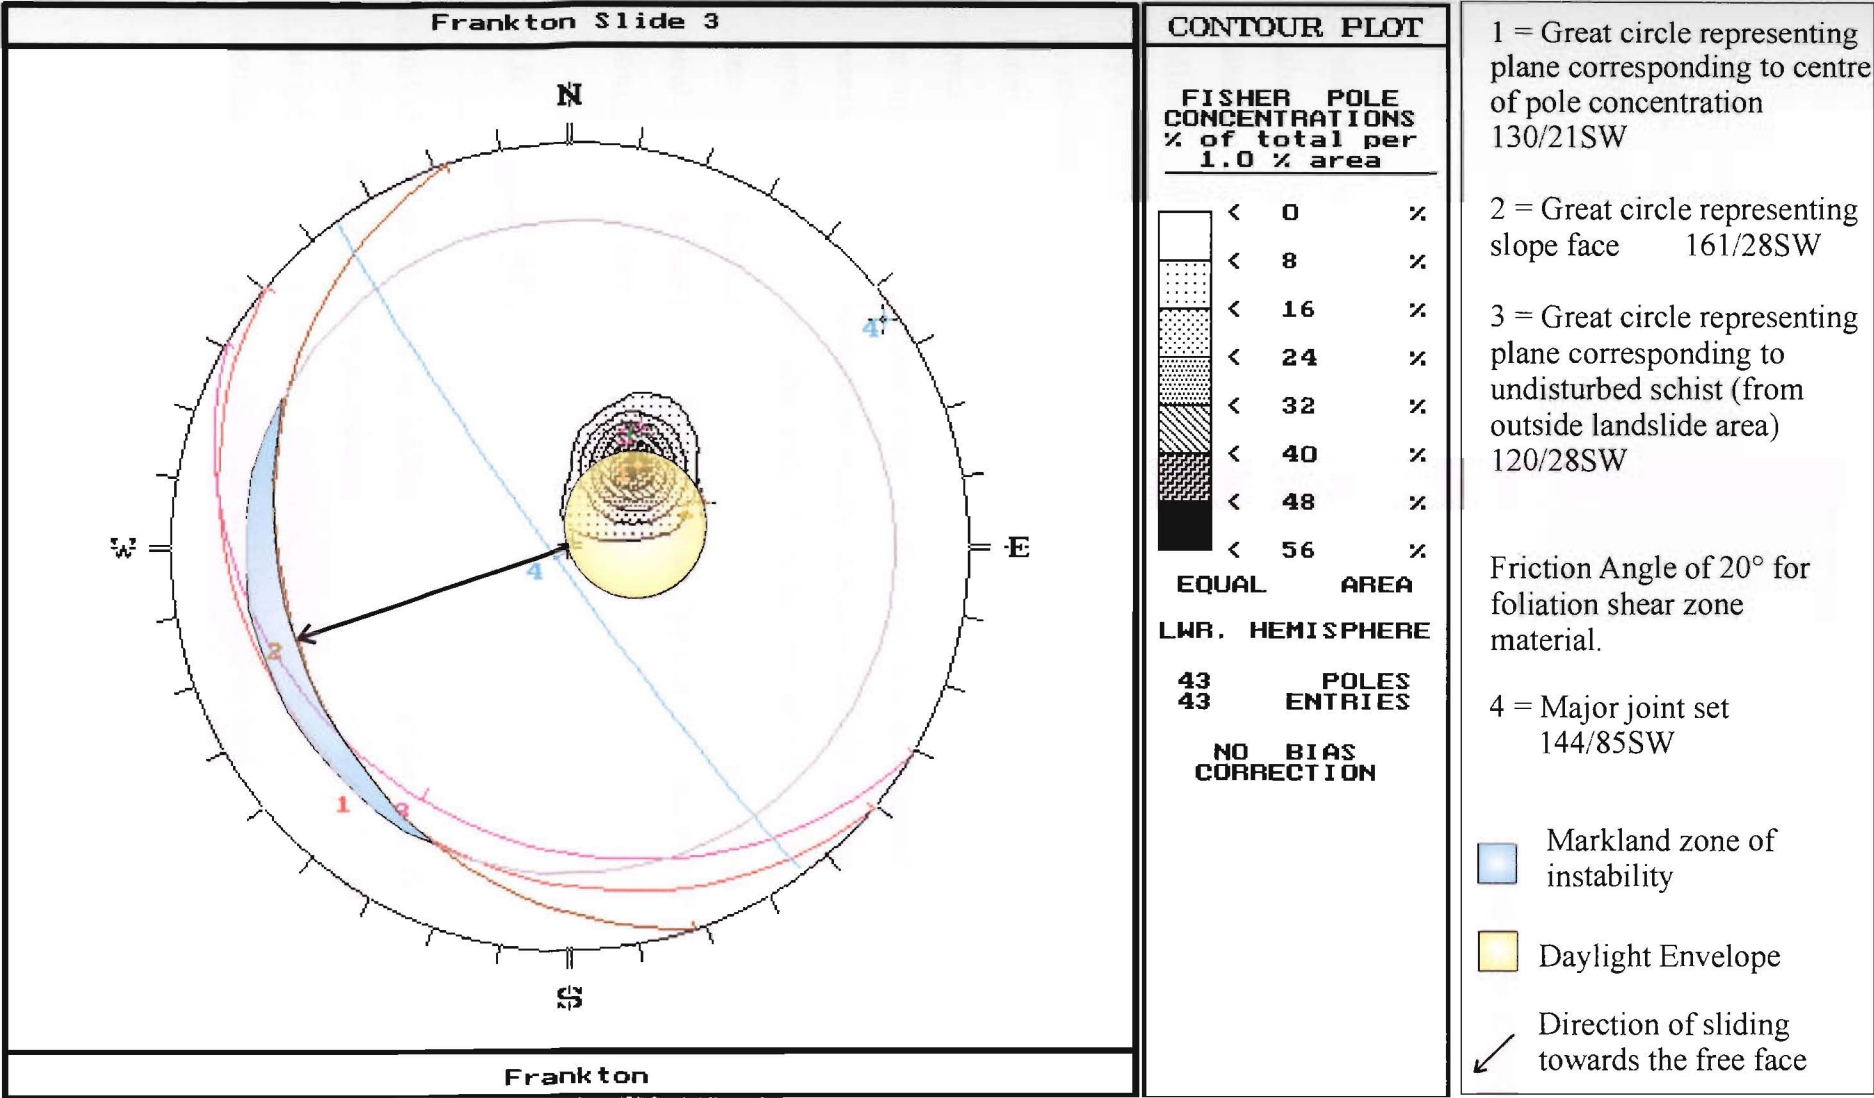
Figure 5.16: Stereonet showing major structural controls of the No. 3 Failure, using a friction angle of 20°, a value assumed for foliation shear zone material. There is a Markland's zone of instability formed.

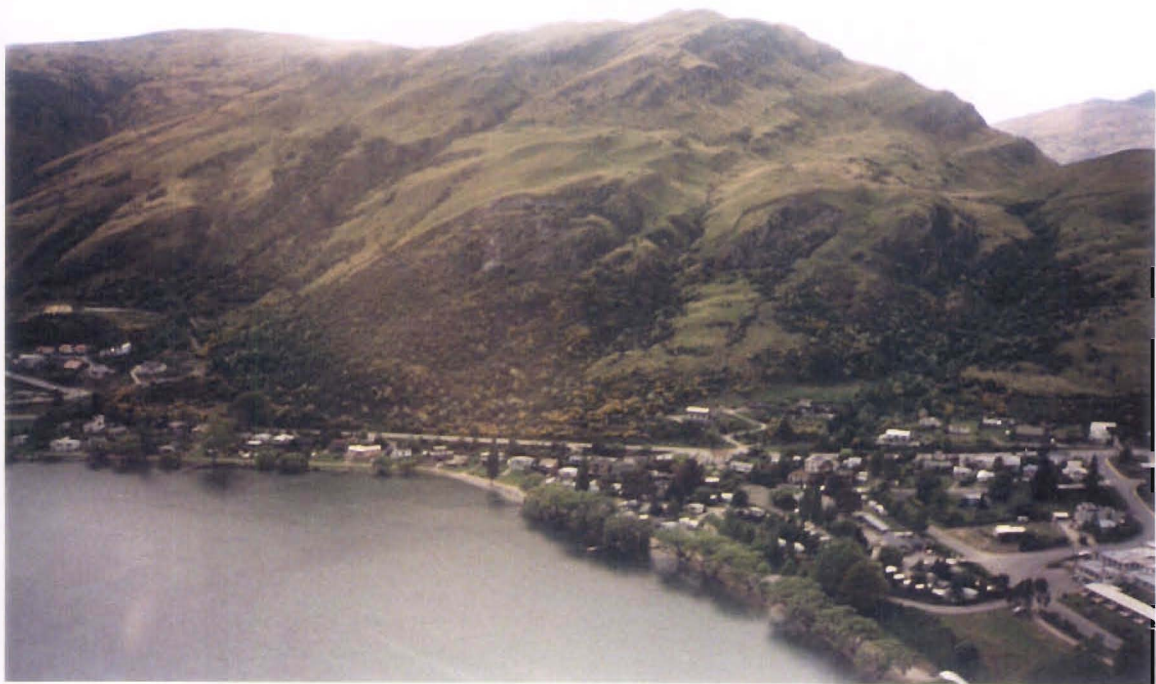
Figure 5.17: Photo looking north at the Marina Heights Failure and Slide No.'s 2 - 5.

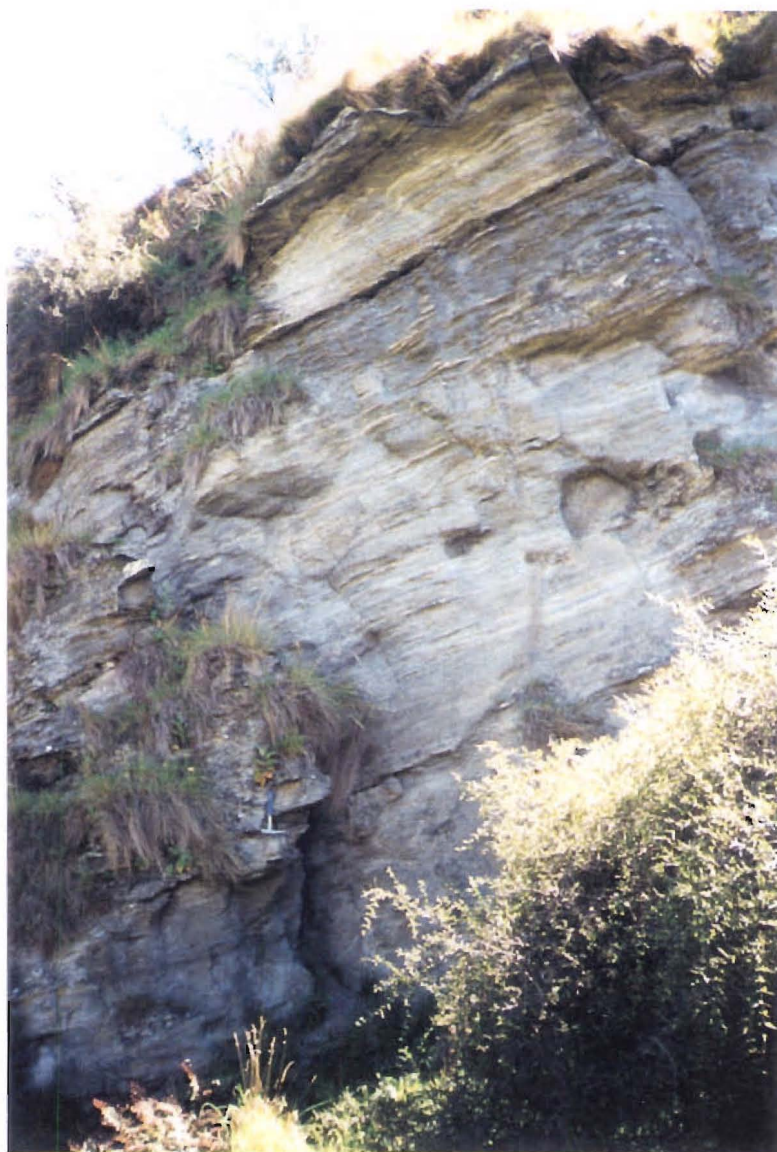
Figure 5.18: Slide No. 4 western lateral scarp. Note the hammer for scale.

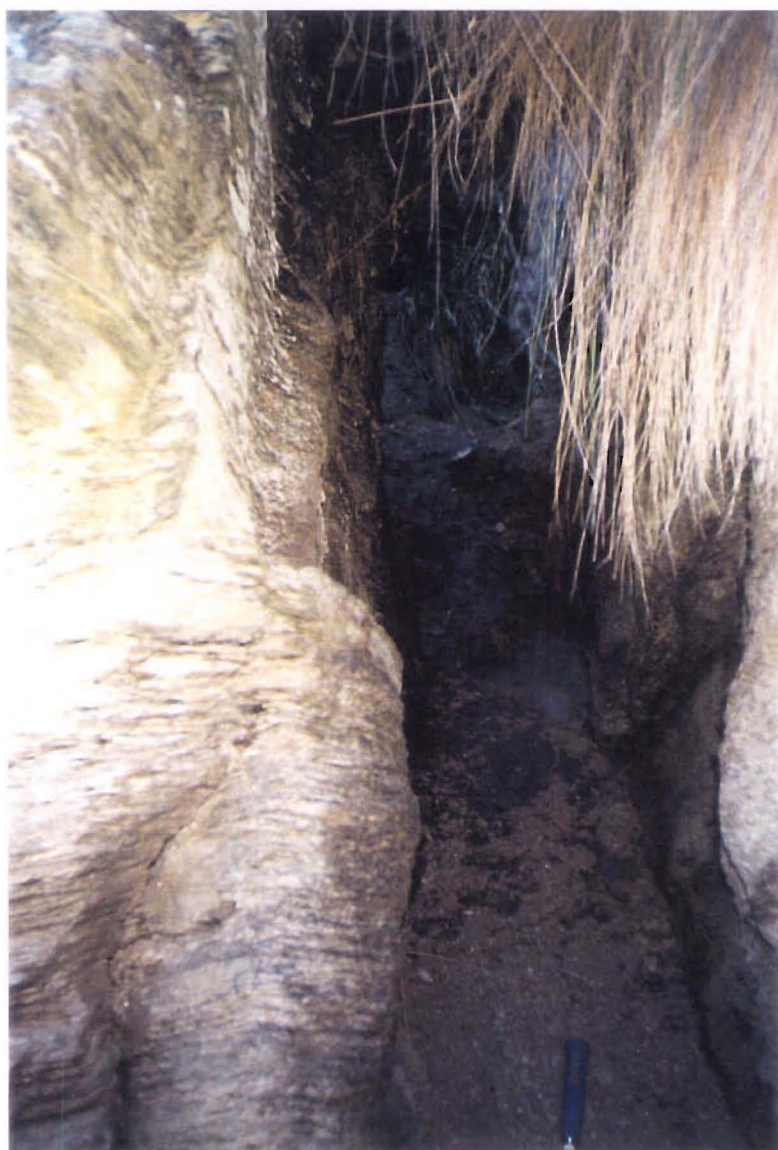
Figure 5.19: Open joint at the base of the western lateral scarp of Slide No. 4. This joint can be seen in Figure 5.18 to the right of the hammer.

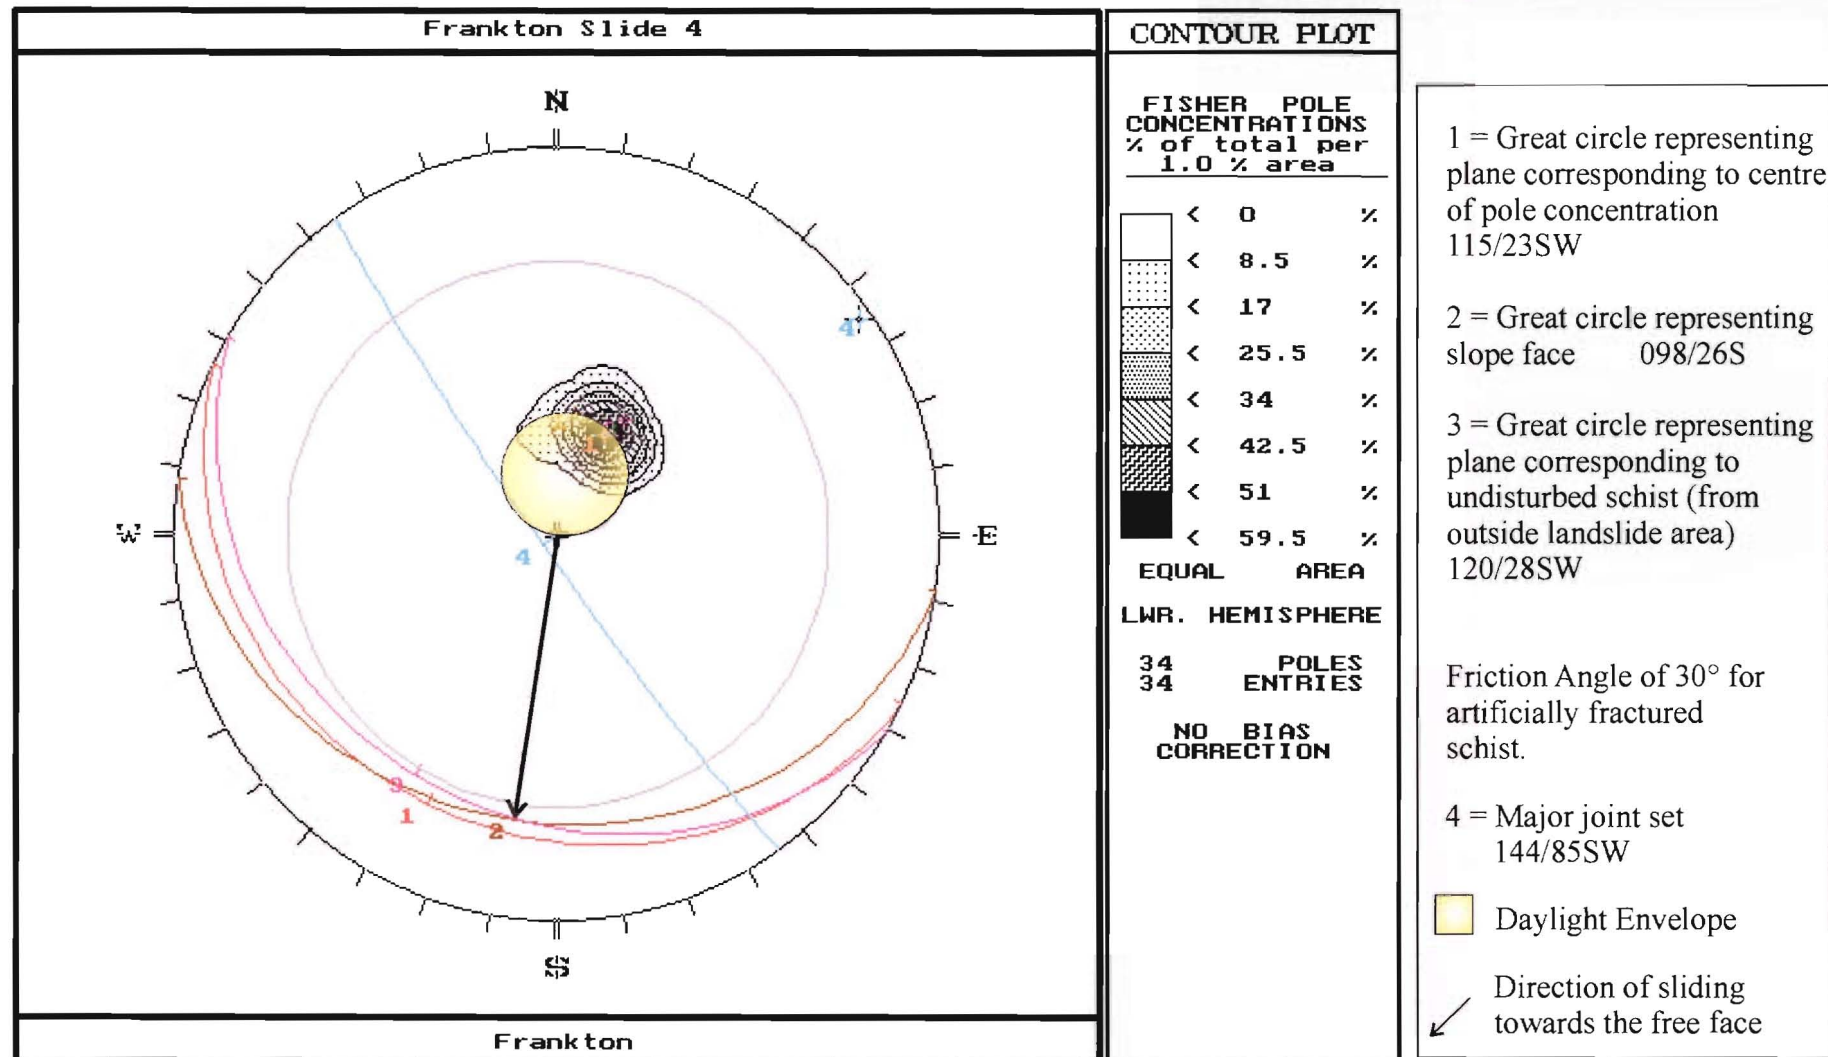
Figure 5.20: Stereonet showing major structural controls of the No. 4 Failure, using a friction angle of 30°, a value obtained from laboratory testing of artificially fractured schist collected from outside the slide area. There is no Markland's zone of instability formed.
